Manhole Inspection Summary

Manhole # S43Y__006MH

Insp Date: **3/4/08 9:51 AM**

Location Address: **1500 decatur st.**

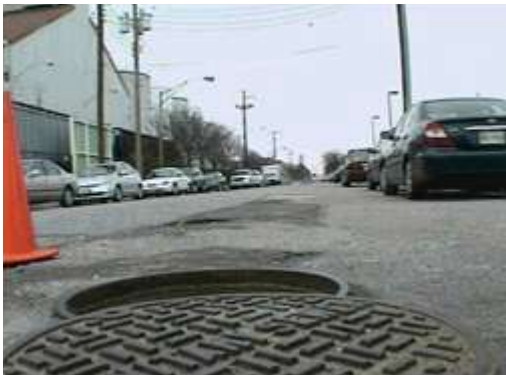
Defect 1

Cover Shape: **Circular** Diameter: **26** (in.) Length: **0** (in.) Dist A/B Grade: **1** (in.)

cover above pavement

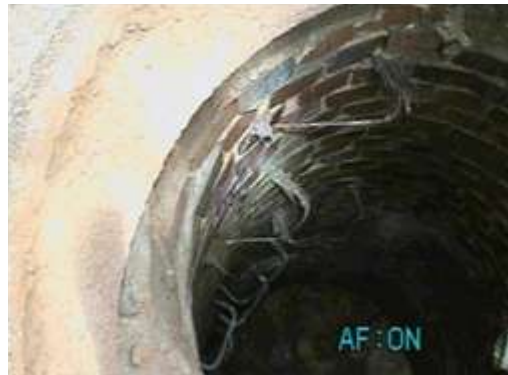
Defect 3

Steps Count: **7** Missing: **3** ☒ **Corroded**

missing/corroded steps

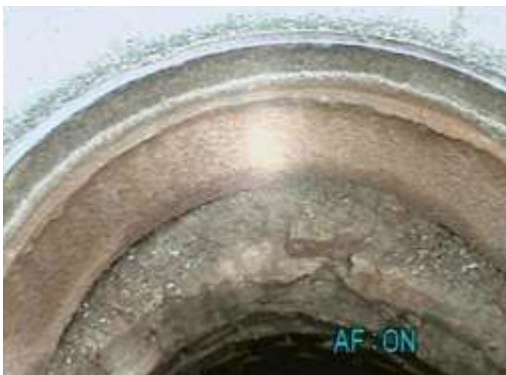
Defect 2

Frame Offset: **3** (in.) Condition: ☒ Sound ☐ Cracked ☐ Leaks

Condition: ☐ Sound ☐ Cracked ☐ Root Intrusion ☐ Loose Brick ☒ **Deteriorated**

frame offset, chimney deteriorated

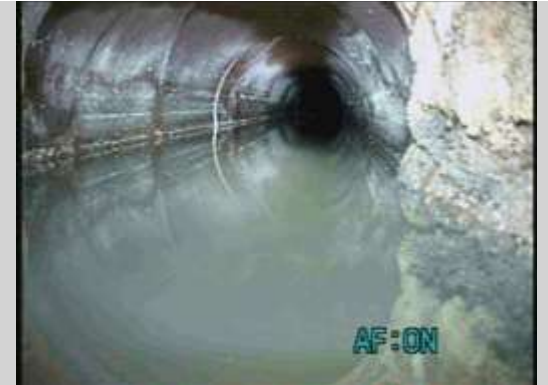
12 O'Clock Outflow

12 in. Circular Gravity Sewer
Pipe Out @ 12 O'Clock

Pipe Material: **Clay** ☐ Pipe Lined

Invert Depth: 11.50 (ft.) Flow Characteristics: **Slow**

Infiltration: **None** Pipe Seal Cond: **Unknown**

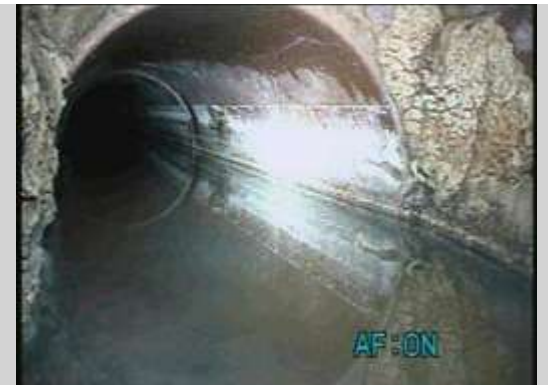
5 O'Clock Inflow

12 in. Circular Gravity Sewer
Pipe In @ 5 O'Clock

Pipe Material: **Clay** ☐ Pipe Lined

Invert Depth: 11.40 (ft.) Flow Characteristics: **Slow**

Infiltration: **None** Pipe Seal Cond: **Unknown**

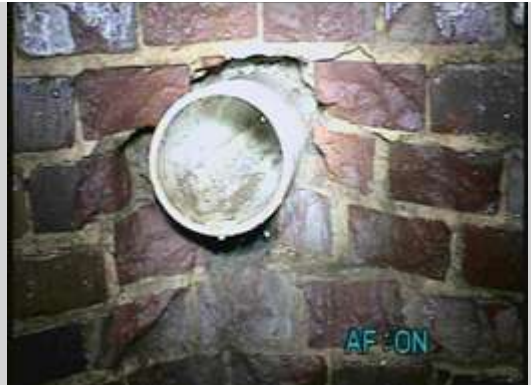
11 O'Clock Inflow

4 in. Circular Gravity Sewer

Pipe In @ 11 O'Clock

Pipe Material: PVC ☐ Pipe Lined

Invert Depth: 5.30 (ft.) Flow Characteristics: Slow

Connects To: House connection / Service line
